4. TITLE (and Subtitle) Phase I Inspection Report National Dam Safety Program Clove Lake Dam, NJ00259 Sussex County, New Jersey		5. TYPE OF REPORT & PERIOD COVERED FINAL / Rept.

17. DISTRIBUTION STATEMENT (of the abstract only) National Dam Safety Program, Clove Lake Dam (NJ 00259) Delaware River Basin, Shimers Brook, Sussex County, New Jersey. Phase I Inspection Report.

CLOVE LAKE DAM  
OVERVIEW PHOTO

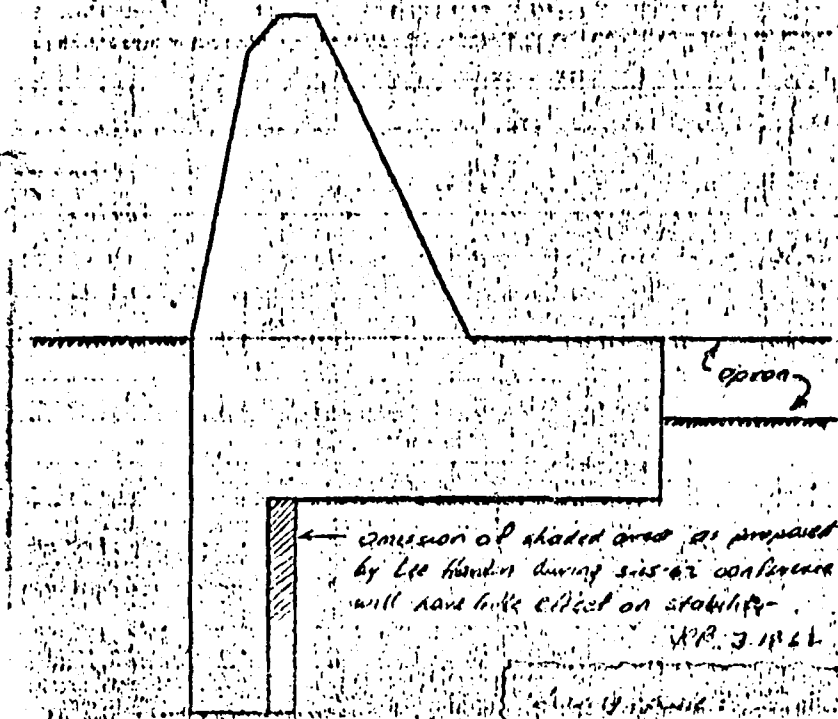
Clove Lake Dam - Recommended Section

← Omission of shaded area as proposed by the Engineer during site conference will have little effect on stability.

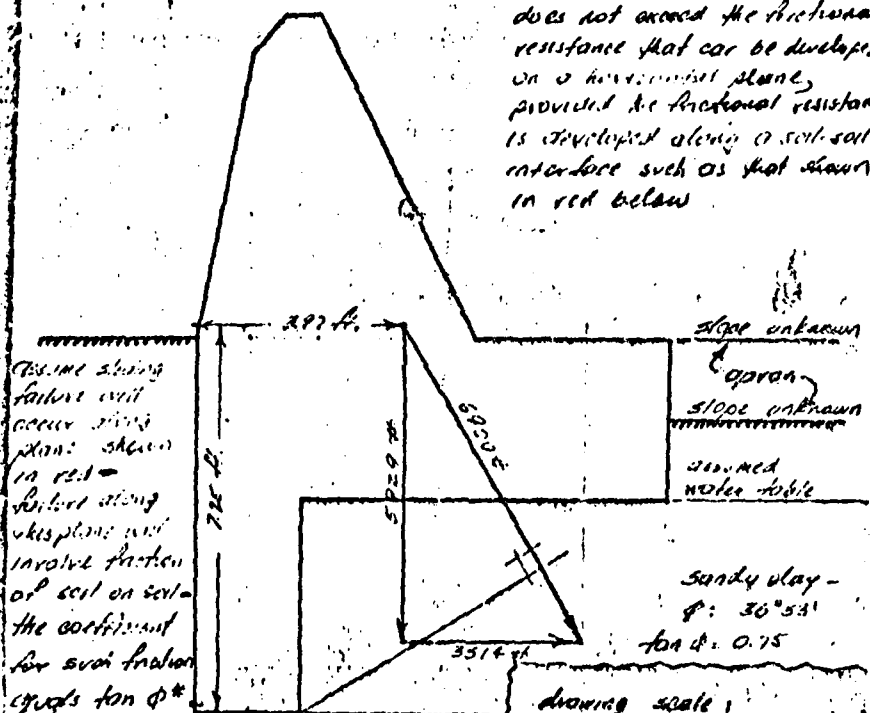
OK because horizontal thrust does not exceed the frictional resistance that can be developed on a horizontal plane, provided the frictional resistance is developed along a soil-soil interface such as that shown in red below

neglecting the weight of soil in area shaded green, the resisting force developed along the plane of sliding is  $0.75 \times 54 \times 74 = 4474$  which is greater than the horizontal thrust.

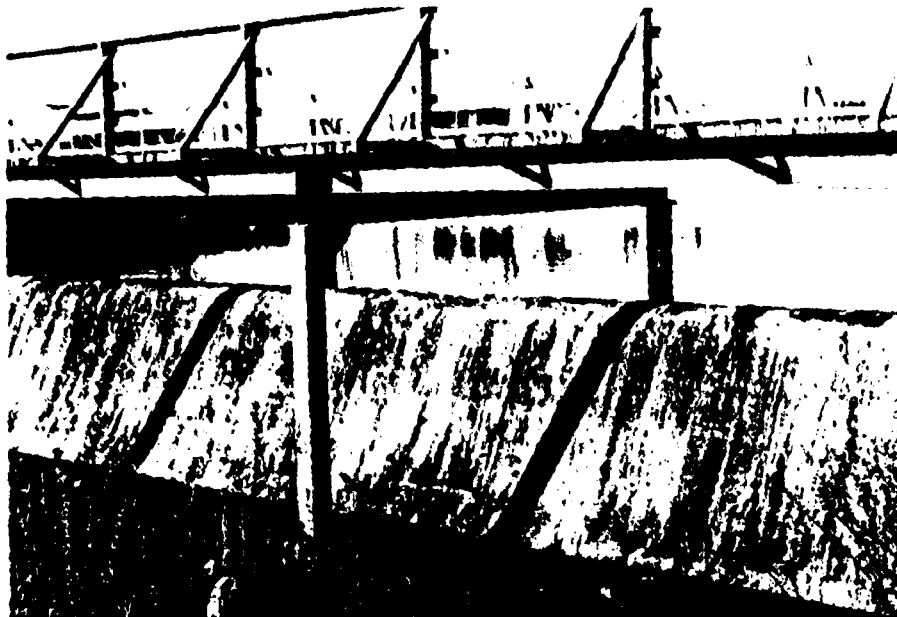
- (1) Spillway. The concrete fish ladder at the left end of the spillway is badly eroded and deteriorated with reinforcing steel exposed. Concrete surfaces around the stoplog slots are eroded. One section of the downstream apron is eroded. A 3-foot long section of the main spillway crest near the left center is spalled to a depth of approximately 3 inches. All stoplogs are badly weathered and some of the steel stoplog supports are bent.
- (2) Service Bridge. The wooden deck was observed to be weathered and worn from traffic. The upstream steel columns are rusting at the waterline.
- (3) Low Level Outlet. The concrete valve chamber is located on the downstream face of the dam and is in fair condition. The pipes on the valve chamber were covered with water. The valves were not operated at the time of inspection; however, they appeared to be in operable condition.

View of spalled concrete on crest of spillway 30 feet from left (south) end. Note brush in d/s channel at toe of spillway.

- (1) Design and oversee procedures to repair the concrete spillway and fish ladder, and the stoplog facilities.
- (2) Relocate the gate valve box for the twin 18-inch draw-down pipes to place the valves on the upstream side of the dam.
